DFRWS 2019 USA

Forensic Analysis of Water Damaged Mobile Devices

Aya Fukami*, Kazuhiro Nishimura

National Police Agency of Japan, 2-1-2, Kasumigaseki, Chiyoda, Tokyo, Japan

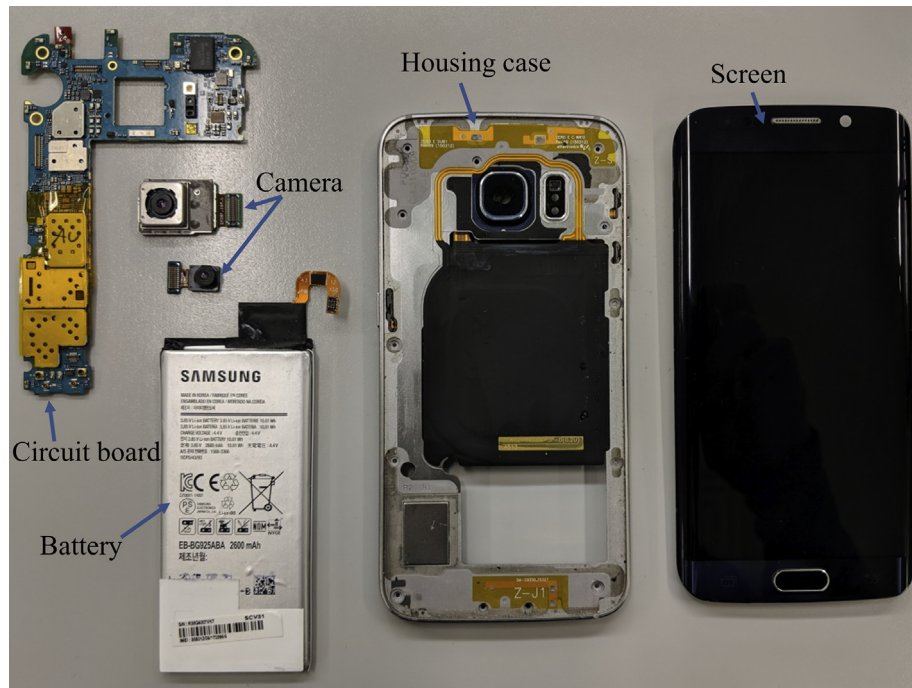
Fig. 1. Example components of a smartphone.

A mobile device typically consists of a screen, a circuit board, a housing case, peripheral components (cameras, antennas, sensors, etc.), and a battery. Fig. 1 shows an example of the internal structure of a smartphone. In a working mobile device, the circuit board controls the operation of the connected components and continuously draws power from the battery. A printed circuit board (PCB) is typically used for the circuit board in a mobile device. The inputs from the user, or the peripheral sensors connected to the PCB, are processed by the main application processor, and the results are passed on to other components, including the display screen. All of the processing that takes place among the components on the PCB is in the form of electrical signals, which travel among conductive metals of the components.

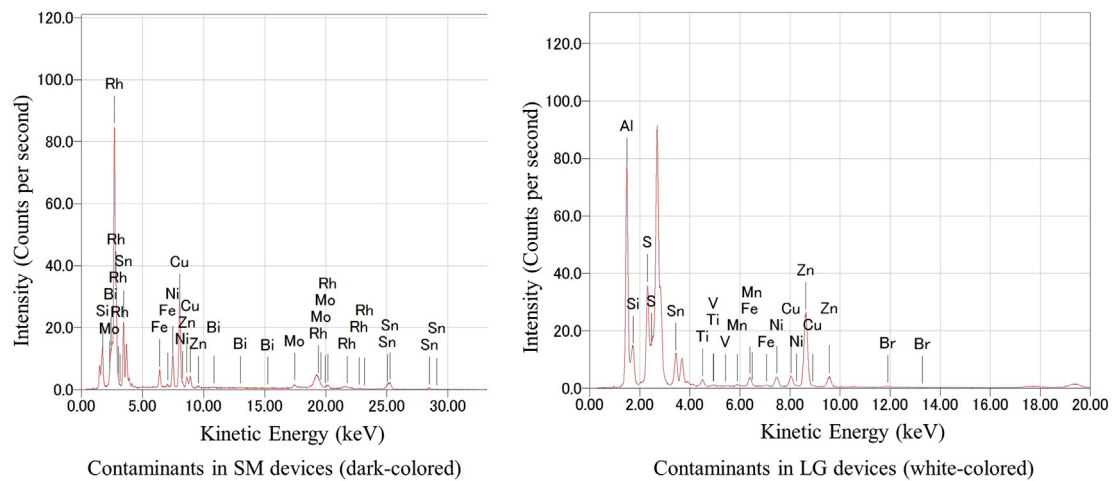
Contaminants left on the PCBs of tested devices were collected and analyzed with EDX. The results are shown in Fig. 5. The detected intensity of different energy levels is plotted in the unit of counts per second. Note that the unlabeled spikes in Fig. 5 indicate rhodium (Rh) detection, which comes from the X-ray tube and can therefore be excluded from the components of the target. The main components of the contaminants collected from the SM devices are copper (Cu), nickel (Ni), and tin (Sn), making up 70 percent of the analyzed contaminants. Since those metals are used for manufacturing PCBs and solder, and were not present in water used for the submersion test, we conclude those colored contaminants are produced as the result of electrochemical reactions of metals on the PCBs, making short circuits.

Meanwhile, the contaminants on the LG devices are primarily composed of aluminum (Al), which made up more than 71 percent of the detected components. As noted earlier, aluminum is used in the housing case of the device. The content ratio of copper (Cu), nickel (Ni), and tin (Sn) in the analyzed contaminants is less than 1 percent in combination. We conclude, therefore, that galvanic corrosion on the LG devices greatly exceeded ECM based metal corrosion.

Since the EDX analysis results show that contaminants in water damaged devices contain metals, we conclude that contaminants in water damaged devices are conductive. Thus, unintentional short circuits can be created with the presence of the contaminants on those devices. Therefore, applying voltage to a PCB without removing contaminants can cause system failure. Note that EDX only detects metal compounds of the target sample, therefore, oxygen and other organic compounds are not included in the EDX composition analysis results.

Fig. 5. EDX analysis results of the contaminants left on the PCBs of tested devices.
